EGG-HWP-8128  
August 1988

FINAL REPORT

DISMANTLEMENT OF BUILDING 666 AND INDUSTRIAL  
WASTEWATER TREATMENT PLANT NO. 4

This report describes the tasks performed to dismantle Building 666, Industrial Wastewater Treatment Plant No. 4, and associated facilities at McClellan Air Force Base (AFB). This report also presents the condition of the site after dismantlement and identifies the cost and duration of the project, and hazardous waste volume generated.

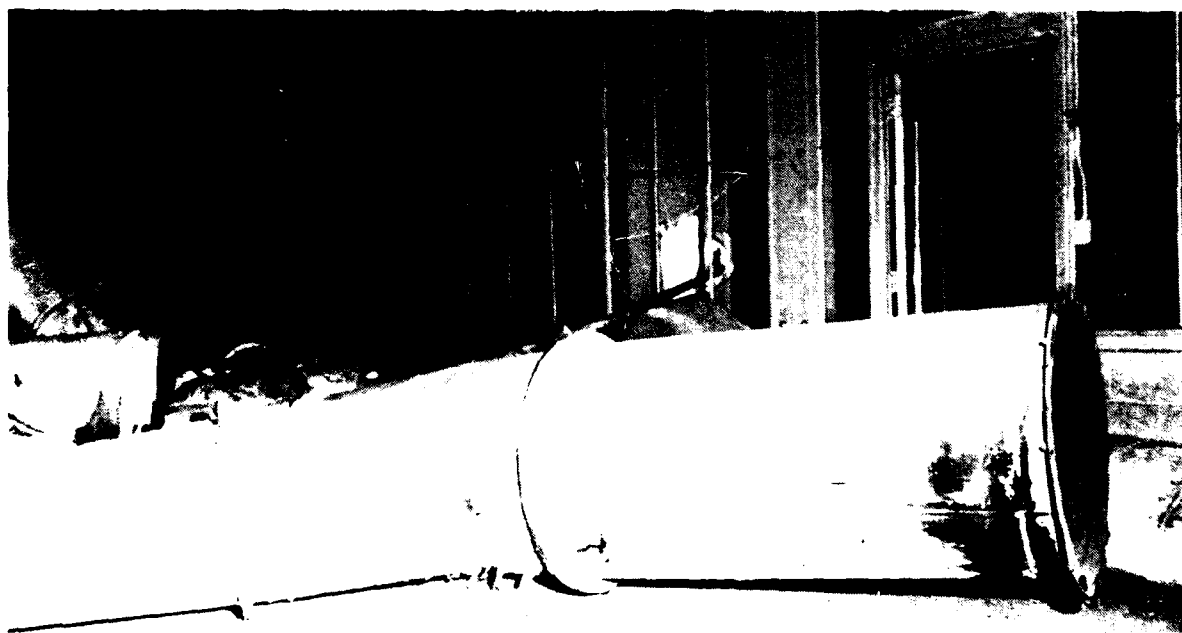
86-251-1-3

In 1982, the rooftop-mounted ventilation units were removed along with the built-up roofing material. The ventilation roof penetrations were then sealed with sheetmetal caps and the roof recovered with built-up roofing materials. During this roofing modification, the toxic exhaust ductwork was cut loose from the roofing vents and allowed to drop to the building floor (Figures 6 through 10).

Figure 10. Building 666 interior, ducting at south end of building.

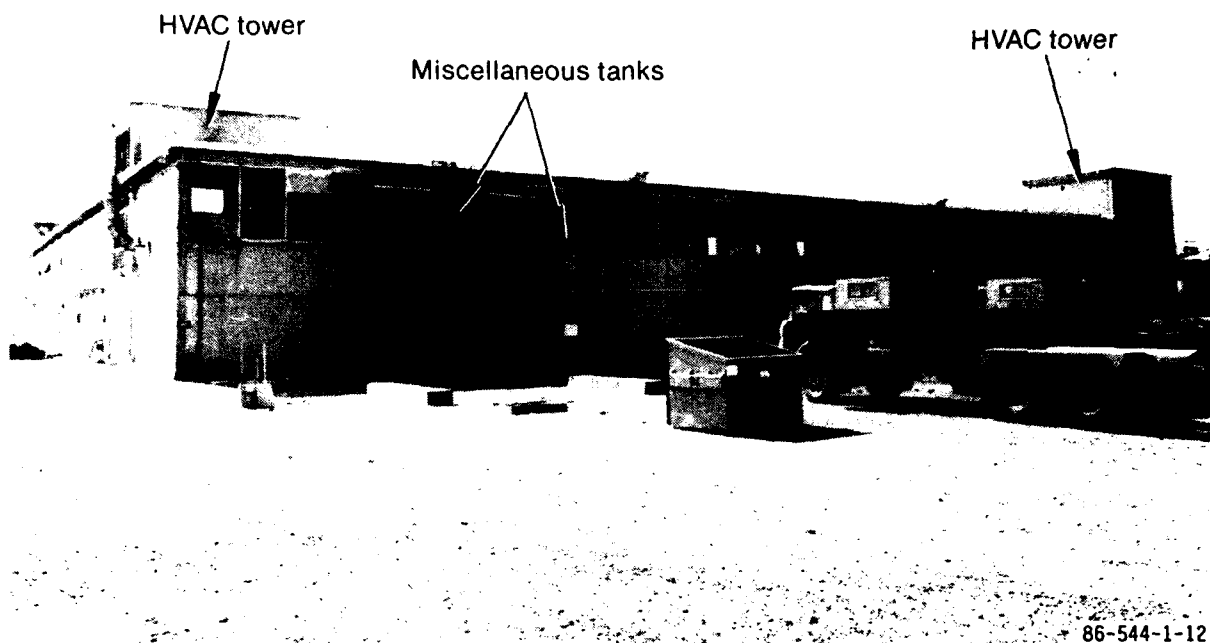
Two carbon steel tanks were located outside the north wall of Building 666 near the northeast corner of the building (Figure 13). The horizontal tank was nearest to the building corner and was mounted on four column supports that were approximately 14 ft high. This empty tank was about 6 ft in diameter and 20 ft long. A pipe led from the tank under the

Figure 13. North side of Building 666.

roadway and emerged from the ground approximately 25 ft north of the building corner next to a pair of abandoned equipment supports. This tank was a recent addition and was not tied into Building 666.

The two empty tanks located outside Building 666 near the northwest corner (Figure 13) were removed with the grapple (Figure 41) and placed in a pile with other material and debris from outside the building. Later, these tanks were sectioned using the shear (Figure 42), loaded on a dump truck, and transported to the disposal site.

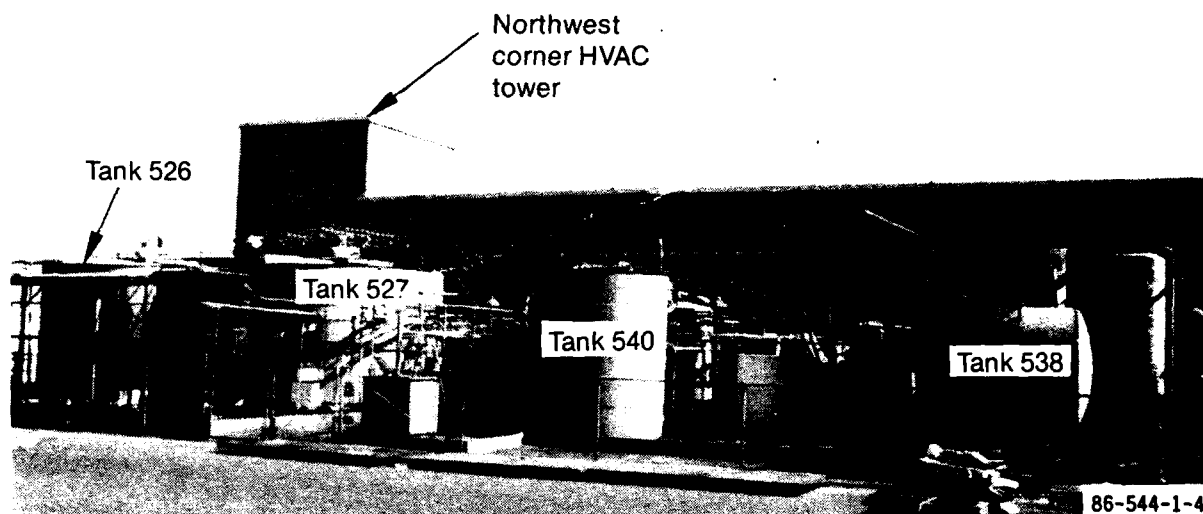
Figure 14. South section of IWTP No. 4 with Building 666 in background.

Most of the tanks were carbon steel with painted exteriors and appeared to be in good condition. Exceptions were tanks 541, 526, and 527. Tank 541, a dilute chromic acid tank, appeared to have been painted with dark gray paint, which was peeling and flaking extensively. The vinyl liners in tanks 526 and 527, treated cyanide wastes retention tanks, were coming loose from the tank interiors. The liner in Tank 526 had pulled away from the north half of the tank wall and had torn and collapsed inside the tank. No tank leakage was visible.

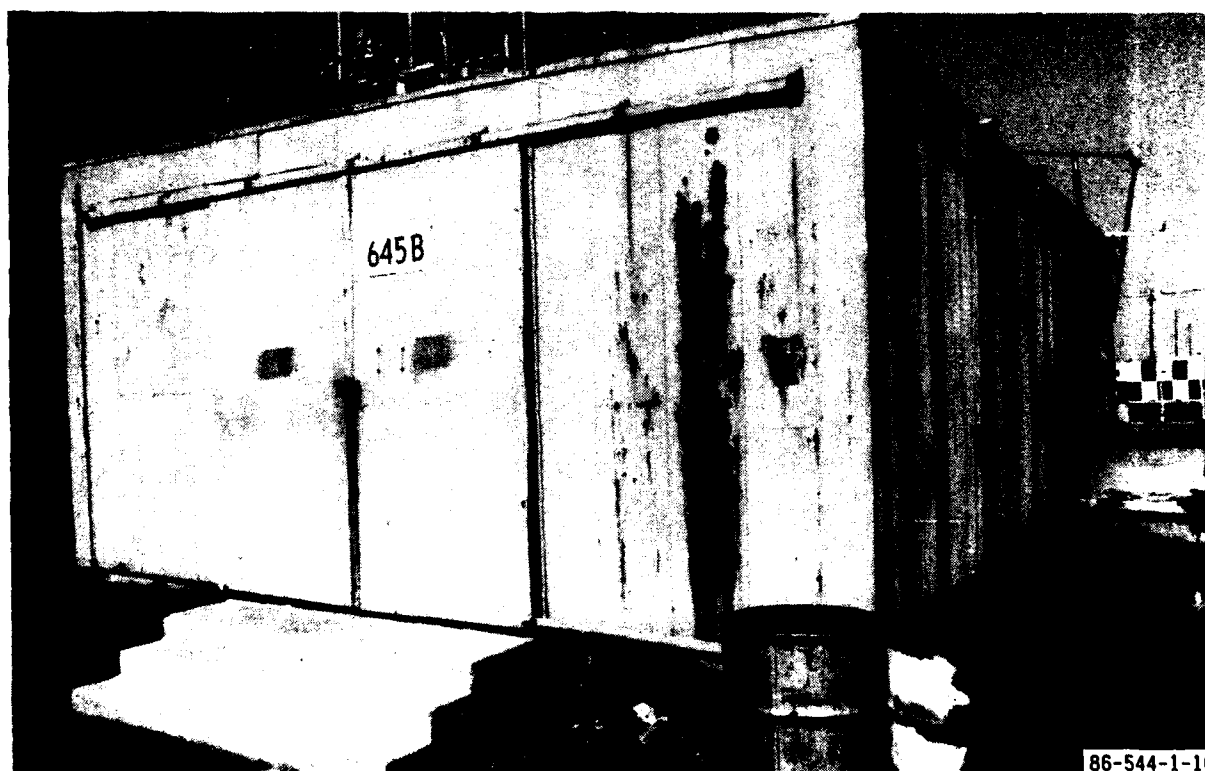
86-544-1-10

Figure 16. Building 645B, south end. The fence at left is the east side of IWTP No. 4's north section.

Building 645B was also considered part of IWTP No. 4. Building 645B was a skid-mounted steel building, approximately 20 ft wide (E-W) by 30 ft long (N-S) by 10 ft high. Wooden skids under the building were deteriorating because of exposure to chemicals and weather. Several drums and bins along the east wall of Building 645B contained liquid which was disposed of as hazardous waste during this project.
